Manhole Inspection Summary

Manhole # S29S1_009MH

Location Address: **3520 Spelman Road**

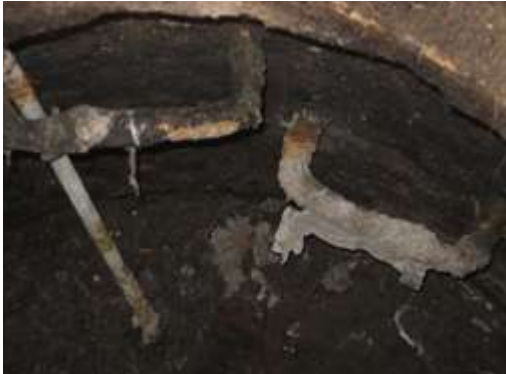
Steps Count: **2** Missing: **0** ☐ Corroded

steps

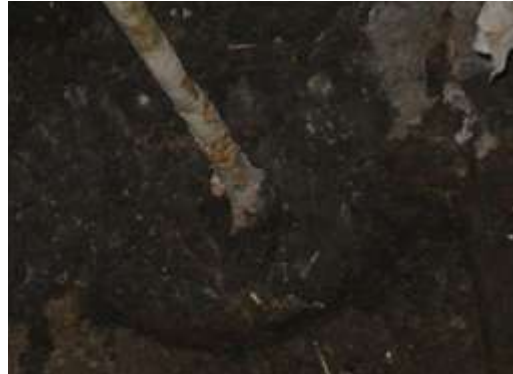
Defect 1

debris on bench

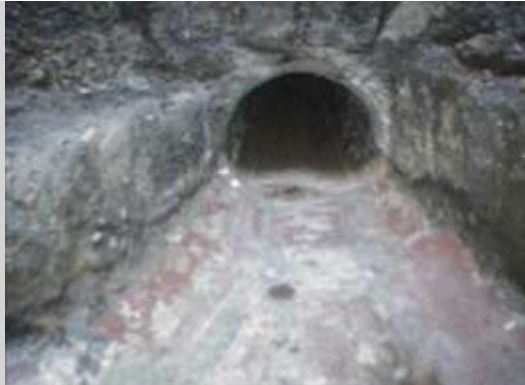
12 O'Clock Outflow

6 in. Circular Gravity Sewer
Pipe Out @ 12 O'Clock

Pipe Height: **7.2** (in.) Rod and Bar (Angled)
Pipe Material: **Clay** ☐ Pipe Lined
Invert Depth: **5.96** (ft.) Flow Characteristics: **Slow**
Deposits: ☒ None ☐ Mud ☐ Sludge ☐ Debris ☐ Grease
Silt Depth: (in.) Deposits Extent:
Infiltration: **None** Pipe Seal Cond: **Sound**

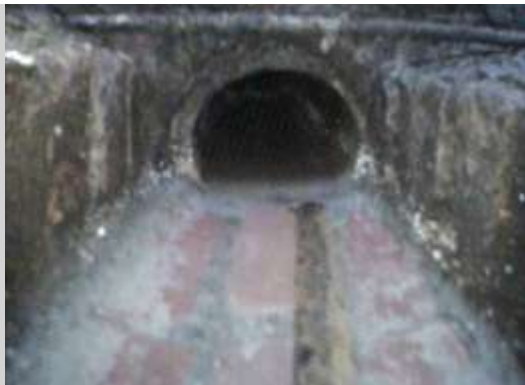
6 O'Clock Inflow

6 in. Circular Gravity Sewer
Pipe In @ 6 O'Clock

Pipe Height: **7.2** (in.) Rod and Bar (Angled)
Pipe Material: **Clay** ☐ Pipe Lined
Invert Depth: **5.94** (ft.) Flow Characteristics: **Slow**
Deposits: ☒ None ☐ Mud ☐ Sludge ☐ Debris ☐ Grease
Silt Depth: (in.) Deposits Extent:
Infiltration: **None** Pipe Seal Cond: **Sound**

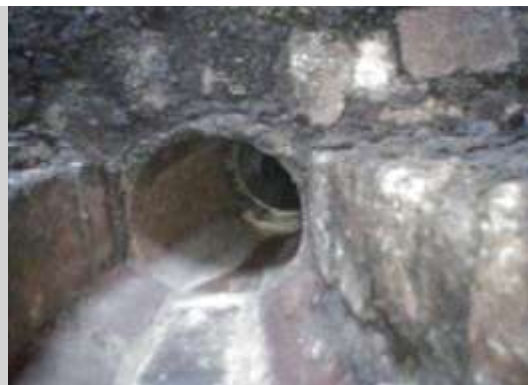
9 O'Clock Inflow

6 in. Circular Service Sewer
Pipe In @ 9 O'Clock

Pipe Height: **6** (in.) Rod and Bar (Angled)

Invert Depth: **5.76** (ft.) Flow Characteristics: **Slow**

Infiltration: **None**

Pipe Seal Cond: **Sound**
